MAJOR CAUSES OF CRACK IN BUILDINGS PROJECT ON THE WALLS AND FLOORS: IN CASE OF WOLAITA SODO TOWN IN PUBLIC BUILDINGS

ABSTRACT

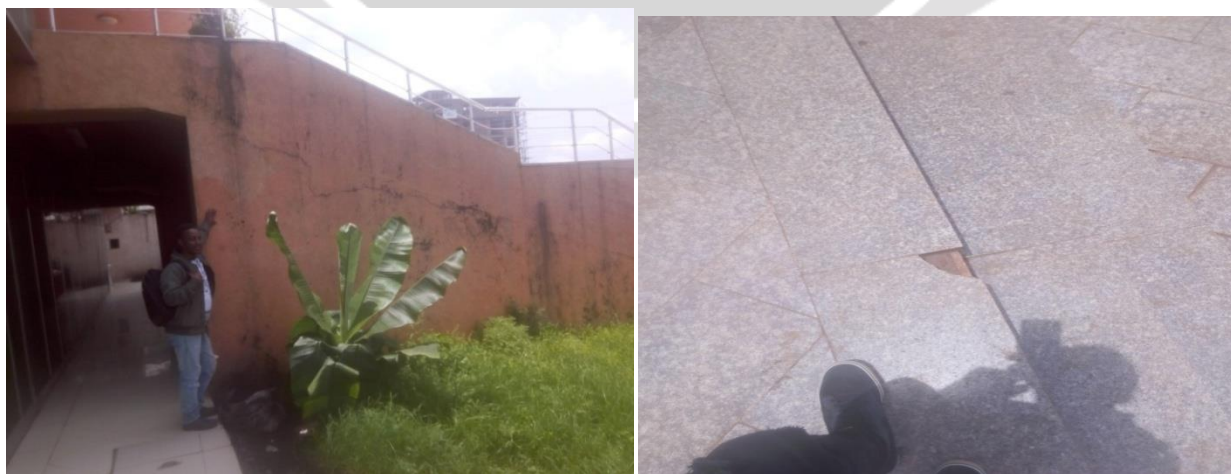
During the observation, a diagonal crack was seen on the front wall of the building near to the gate (entrance) of the building. This crack was observed near to the entrance of the building. In addition, a diagonal crack was also observed near to the window of the building. A diagonal crack to the window was seen in F1, R3, W3 and F2-R2 and W2. The causes of the cracks were due to both plastic and to drying shrinkage. The plastic shrinkage is caused due to water ratio is so much. Too much water will take up space, causing the solid ingredients of the mix to separate. The drying shrinkage were caused due to the contracting of a hardened concrete mixture which resulted due to the loss of capillary.

The drying shrinkage cracks were occurred due to the properties and proportions of components, as well as mixing manner, in addition, it can be resulted because of the amount of moisture; while curing dry environment. (as seen externally) (As observed Externally) (see F4,1) The crack is wider at the top and become narrow as it travels downward. The cause of the crack may appear when it is built on shrinkage clay soil like block cotton soil and shallow foundation.

Figure 1. Picture of Diagonal cracks on wall and interior defect ceramic floor

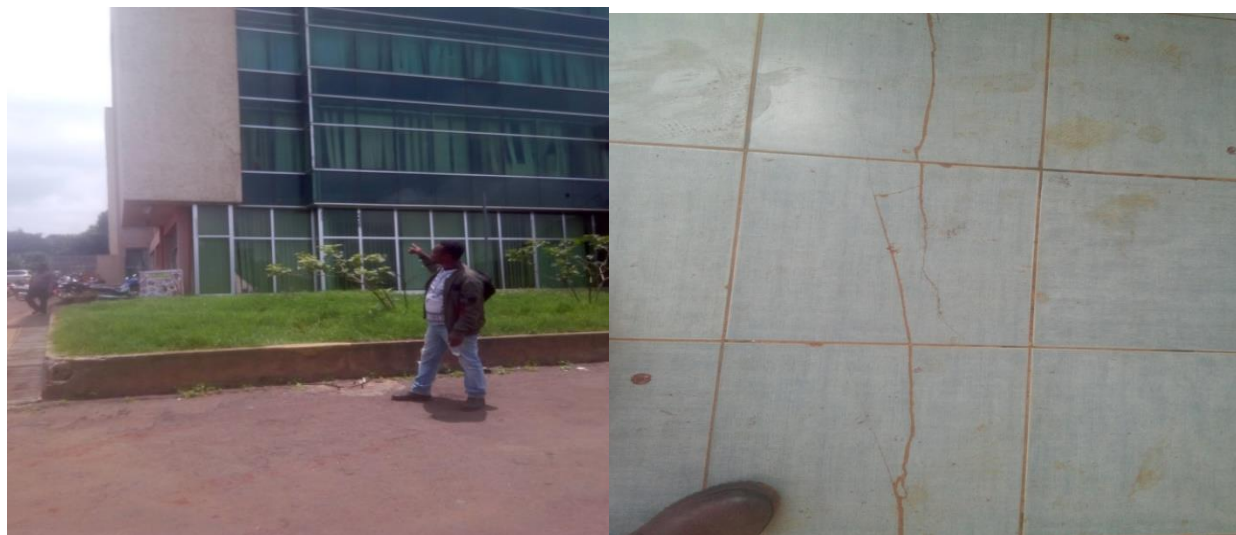
Another types of cracks that was observed at wolaita Sodo Administrative office building was vertical cracks on the floor. The floor where this vertical crack appear was F1-R3 and F1-R2. The cracks may appear due to a combination of poorly foundation on footing, blasting or on adjacent building (as displayed in Fig,3.)

Figure 2. Picture of Diagonal cracks on wall and floor

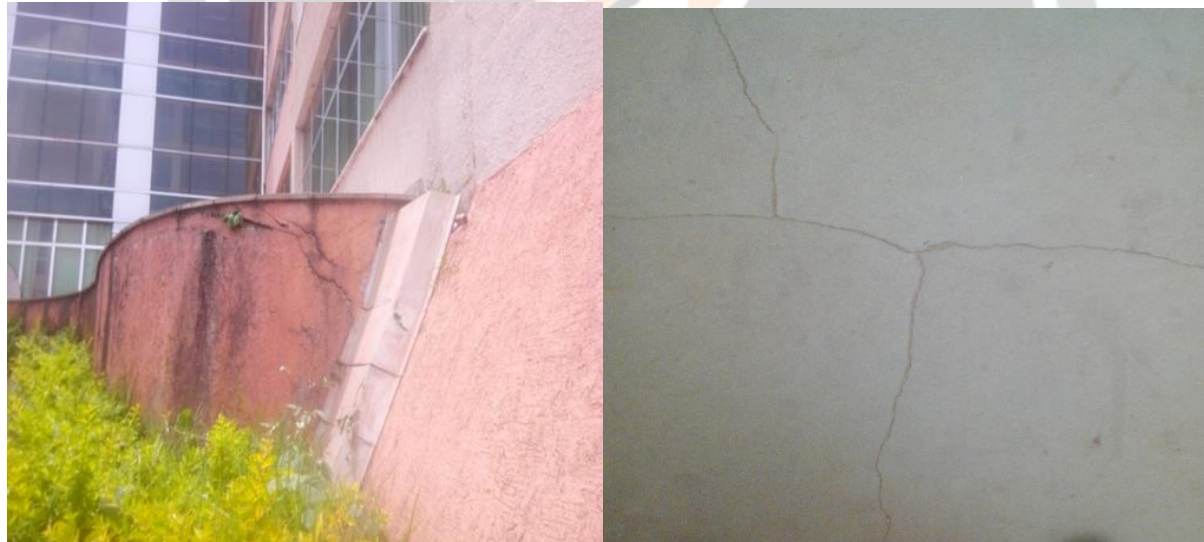
Moreover, random cracks were observed on floors in the internal building. The main cause to this cracks may be due to moisture movement of shrinkage soil (block cotton soil) when the foundation is shallow. The building blocks that was seen in such crack was F1-R2 and F1-R3.

Figure 4. Picture of random cracks wall and floor

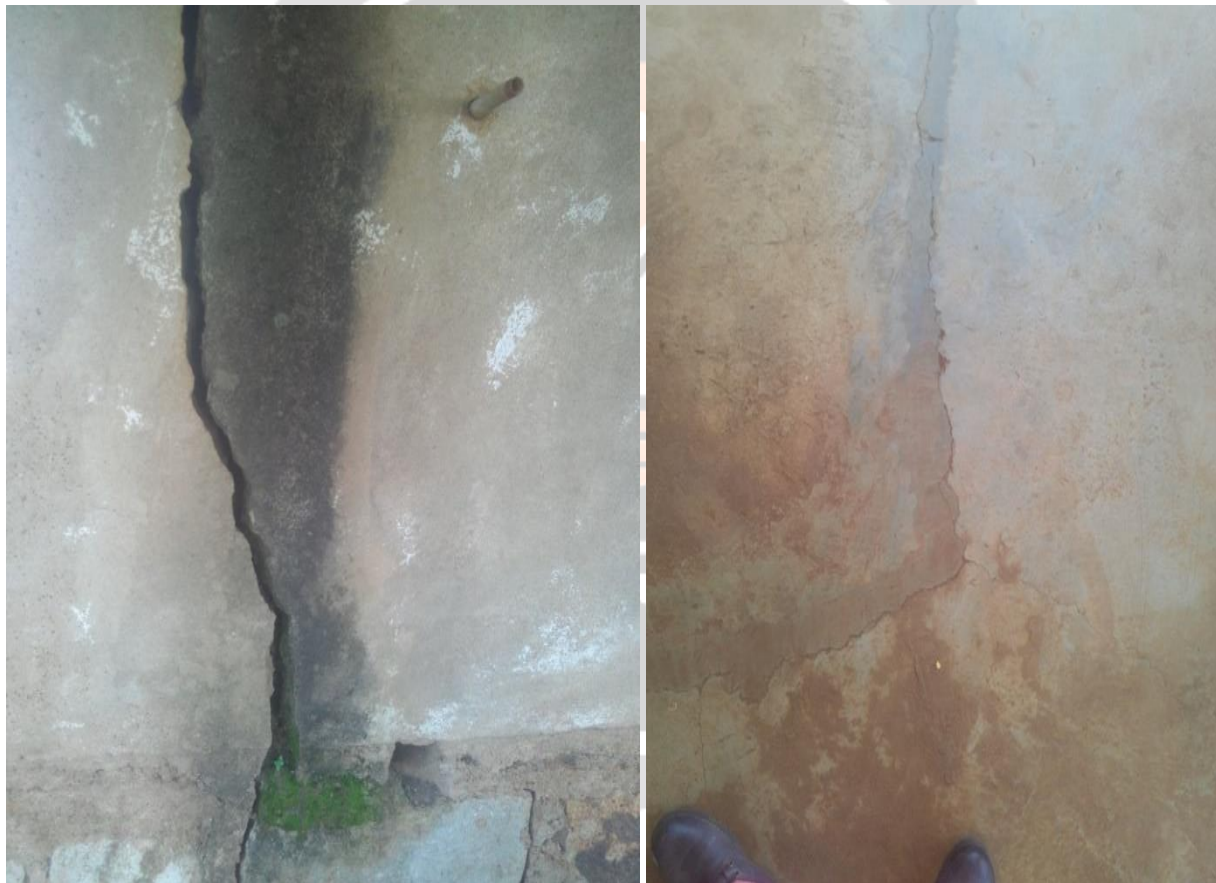
Figure 5. Picture of Active Vertical cracks wall and Horizontal crack floor

The main parts of the building which were affected by active cracks were F0-B, -R2-w2, F1-A-R3-w2, the main causes to the active cracks. The main causes to the active cracks of the building was due to damage on /in reinforced concrete structures. It was observed under in-service conditions. The width of the crack on the floor was medium (1mm to 2mm).

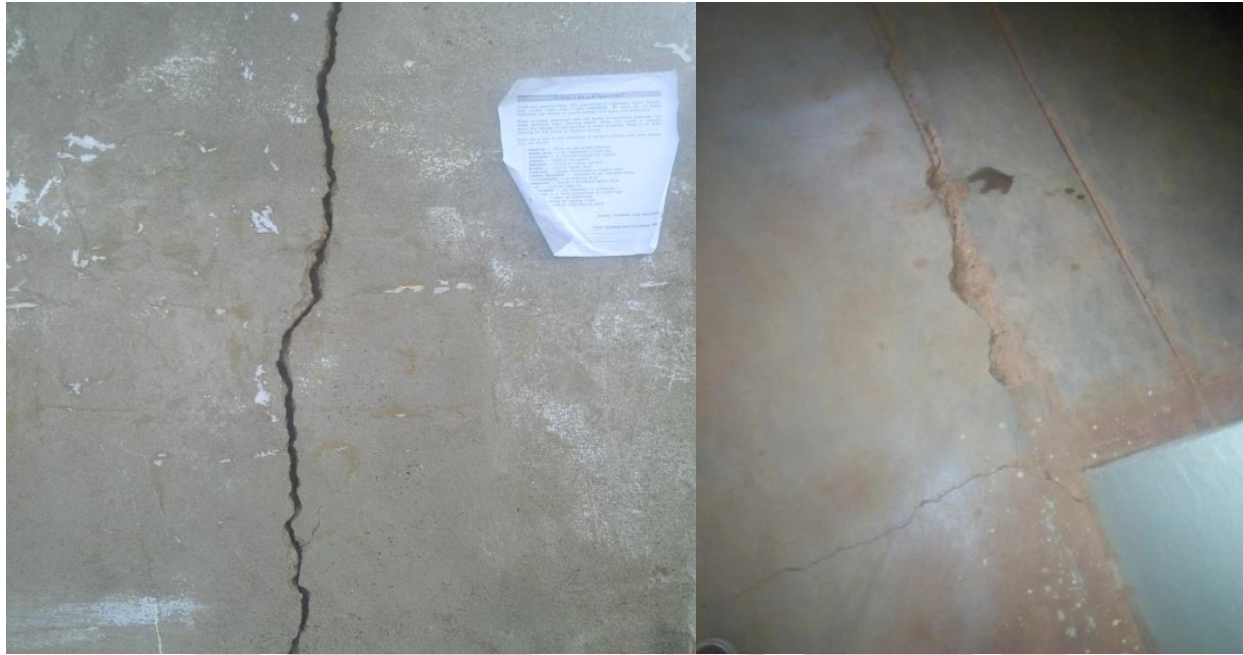
Figure 6. Picture of Active Vertical cracks wall and Horizontal crack floor

The crack has a continuous movement that moves in one direction at a uniform speed and is generated by the application of a length of amount of stress on the material, usually more than the designed stress holding capacity of the material. It has one millimetre wide.

Another type of cracks (as displayed in plate 4) occurred at wall F0, A-R3-w3(as seen external view). due to the earth under the house is not strong enough to support the weight of the structure, so the structure starts to move

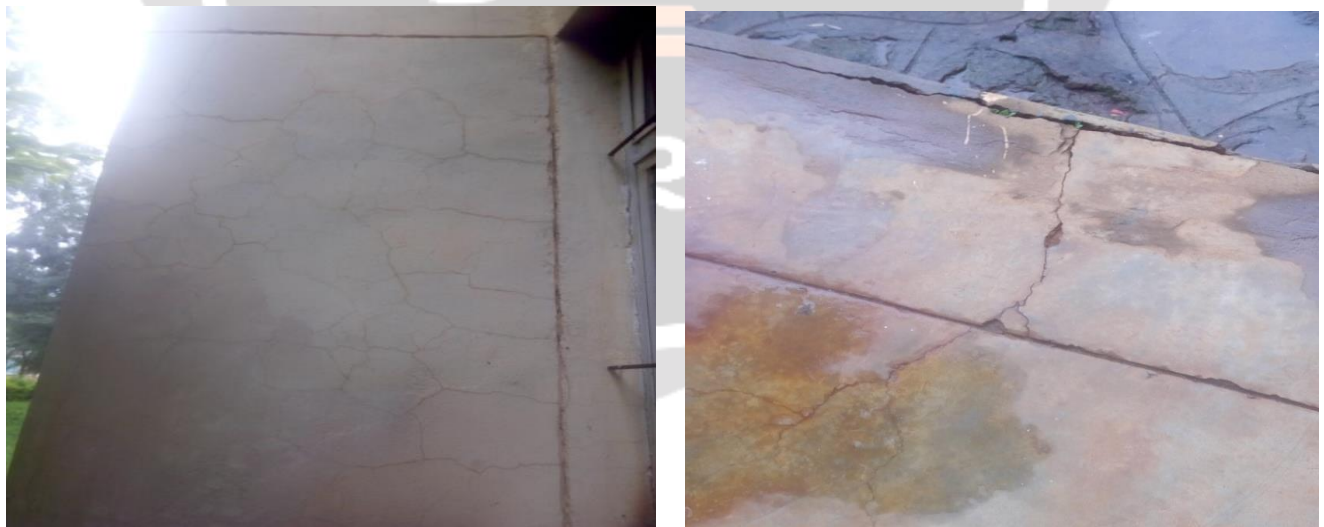
Figure 7. Picture of Random cracks wall and Horizontal crack floor

During the observation, there was also seen a horizontal crack on the wall due to excessive unbalanced soil pressure and it has seen near the center of the wall and nagger to the top of the wall. In addition to the other types of cracks which was seen during the observation was random crack. The cause of the random cracks may be settlement foundation crack probably occurred during the initial flooring settlement. It was observed in the wall F1, -R-2-w3 and F2-R2-w1. During the observation, wide diagonal cracks were seen in the buildings of Ottona referral hospital. It was occurred due to settlement of foundation, if true is possibility of further movement, it was characterized by

tapering and were wider at the top, and occurred due to foundation settlement. The floors and walls affected by this types of cracks were-F0, R1-w4, F1, R3-w4 and F2, R2-w4. The movement of the wall was diagonal.

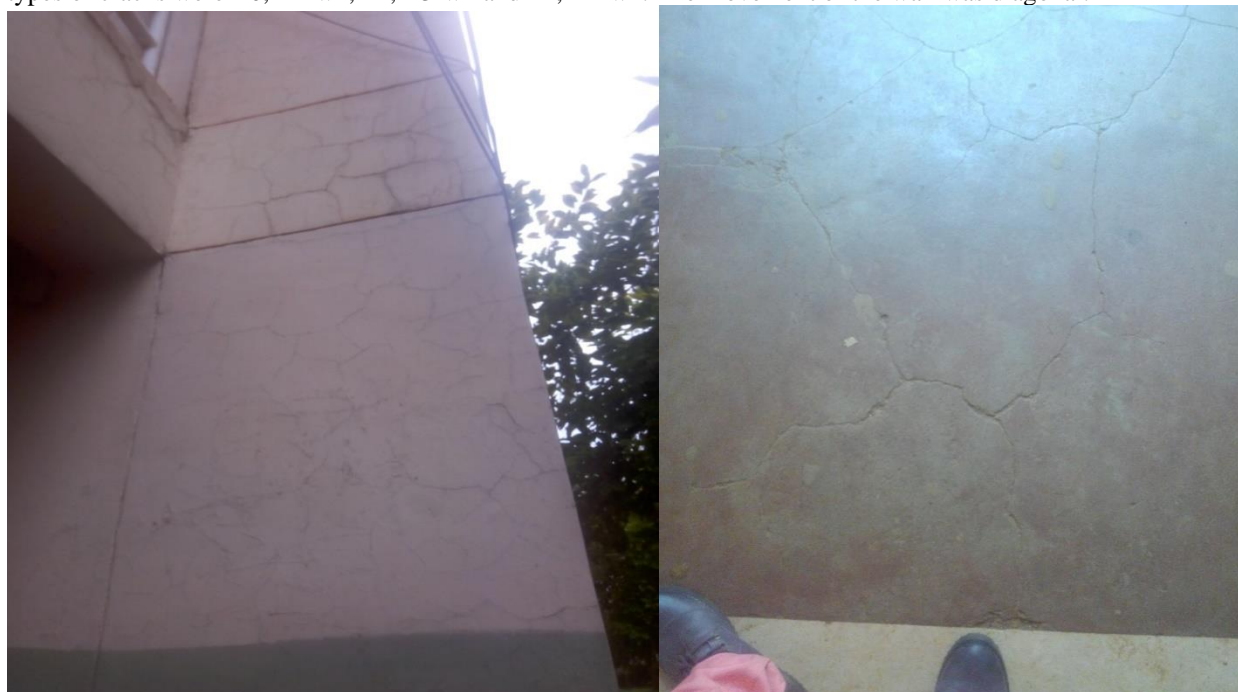
Figure 8. Picture of Random cracks wall and Random crack floor

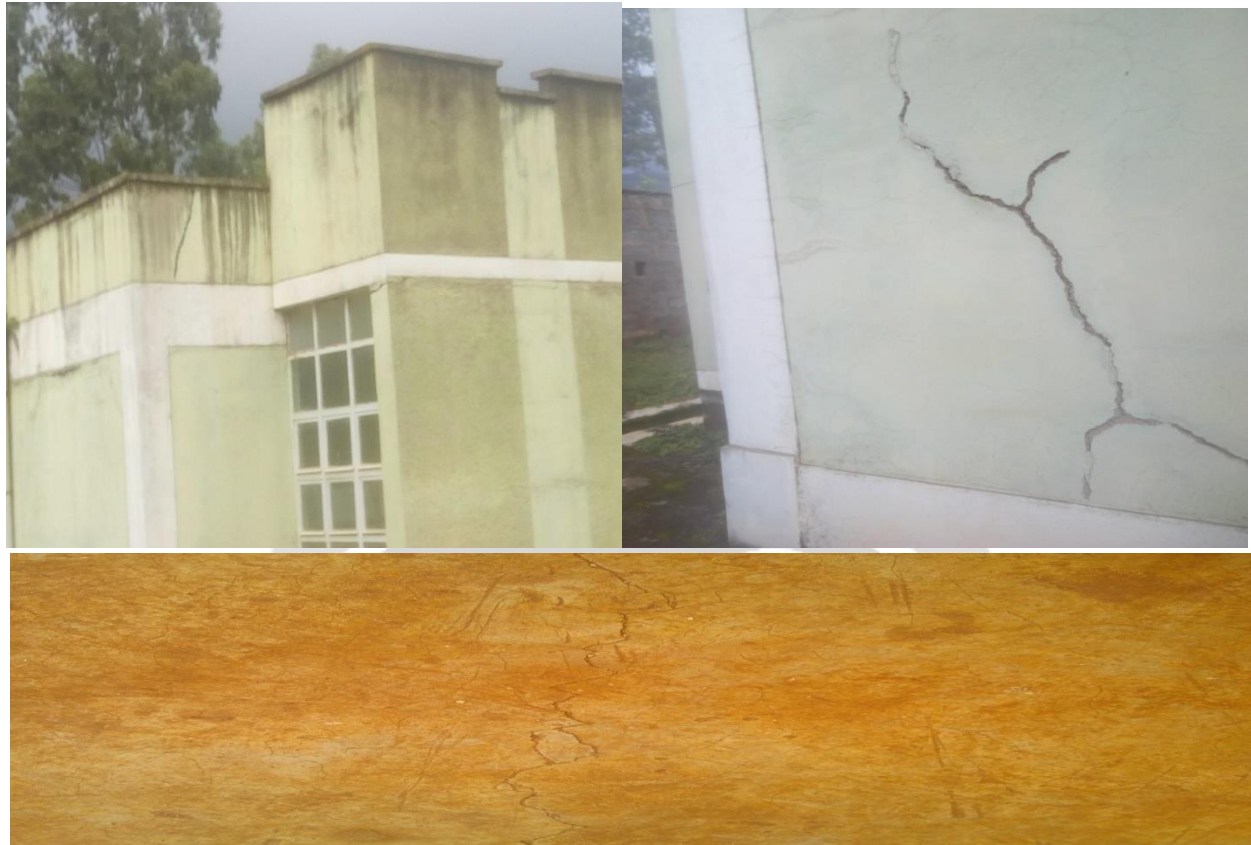
Figure 10. Picture of Active Diagonal Crack for walls and Random Crack for floor

During the observation, it was seen that the major cracks on the floors and walls of the building were surface cracks. Hence, it is a shrinkage crack. The shrinkage cracks observed could occur due to the excessive use of cement to sand, and also not gluing adequate covering services. In addition, drying shrinkage may occur due to the contracting of a hardened concrete mixture due to the loose of capillary water. This crack was seen F1-R2-w4, F2-R2-w5 and F2-R4-w2.

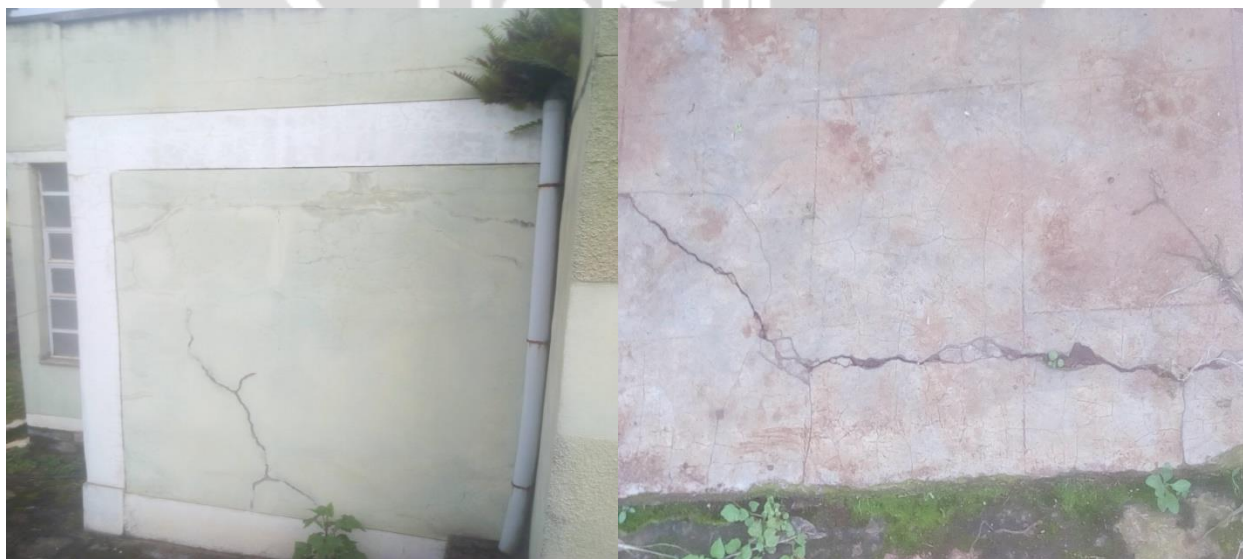
Figure 11. Picture of Active Diagonal Crack for walls and Horizontal Crack for floor

Regarding the cracks observed on the walls and floors of the building. It was observed that most observed walls and floor cracks were horizontal cracks. Horizontal cracks were observed in student learning classroom (F0)- students learning rooms near to the construction department -w1, it was also seen in students learning classroom (F1)-R2-w2 and wall a student's GITIZED learning classroom blocks 4 -room2 w2. The observed horizontal wall cracks were 0.73 mm span width. It was also observed that the long spanned been (7.22 x6mm=7.3m). It may be caused by excessive unbalanced soil pressure and occurred near the centres of the wall and nearer to the top of the wall.

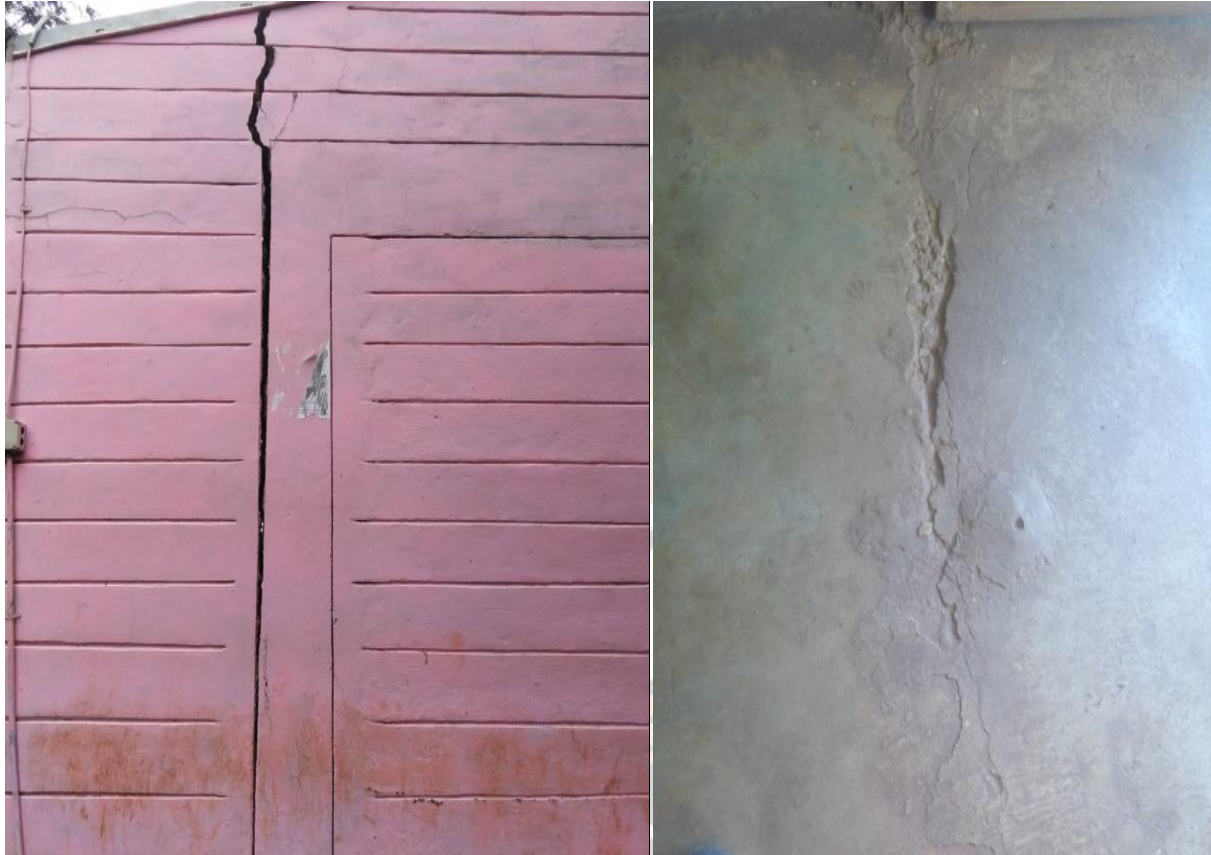
Figure 13. Picture of Active Vertical Crack for walls and Horizontal Crack for floor

Based on the external observation, the types of cracks at wall F0-4-R3-w3. The horizontal cracks which were observed around the walls were due to the very large room spans.

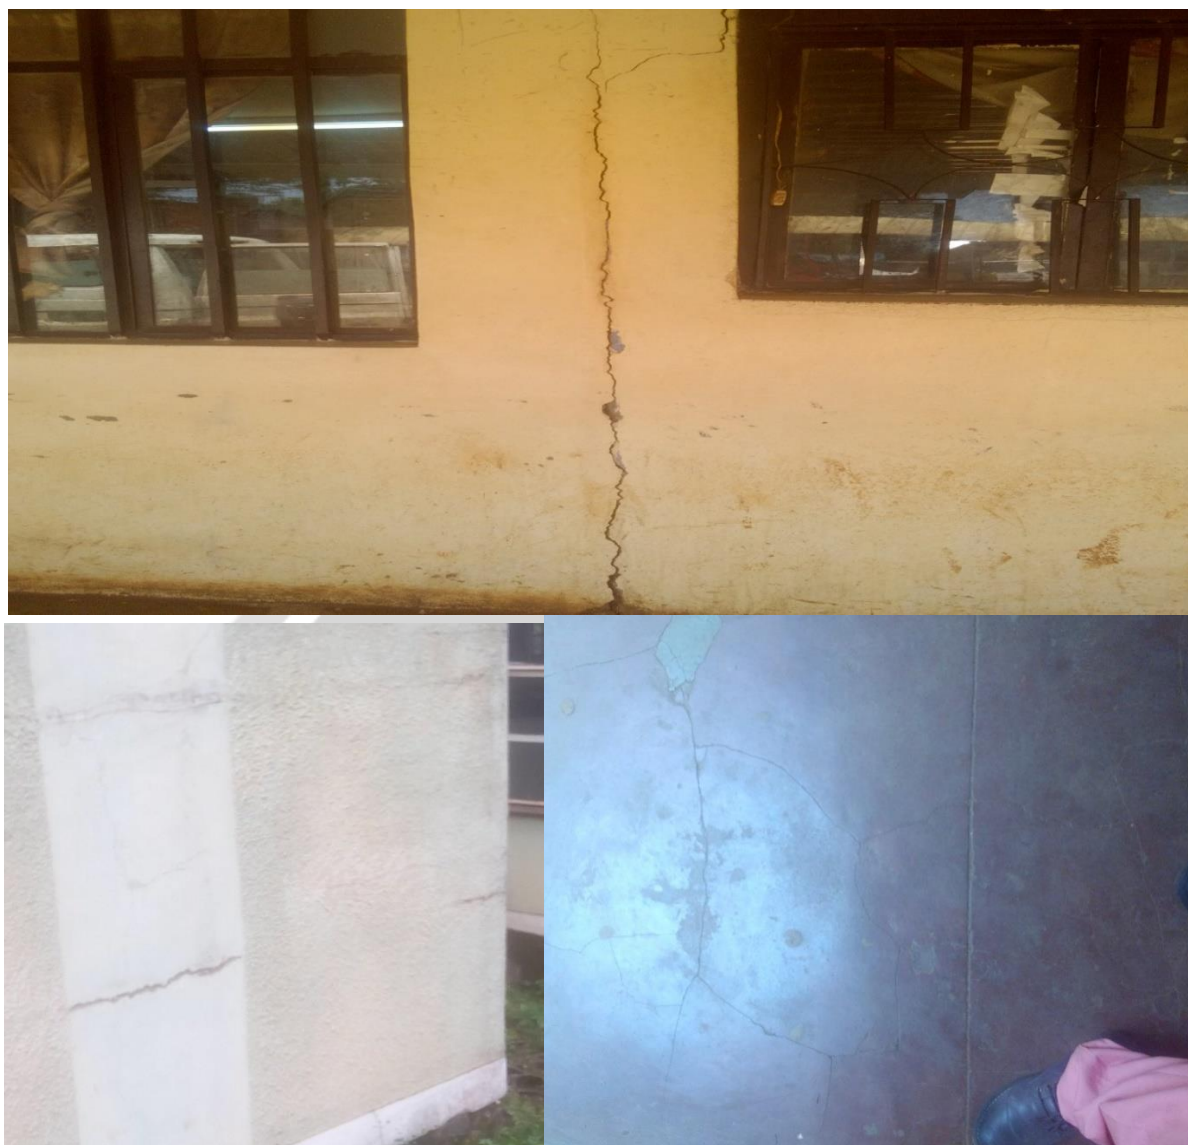
In addition to the horizontal cracks that were occurred due to the very large room spans, excessive unbalanced soil pressure, the third causes to the occurrence of cracks on the walls on blocks 4 floor 1, block 4 floor 2 and block 4 floor 3 in the GITIZED students learning room was due to foundation settlement. The possible causes to this crack were shrinkage of concrete or mortar. Land soil settlement, soil pressure and construction defect.

Figure 13. Picture of Active Vertical, Horizontal Crack for walls and Random Crack for floor
