Influence of Road Feature Variables on Accident Rate in Cameroun. Case study: The road triangle Yaounde-Douala-Bafoussam-Yaounde Highway.

ABSTRACT

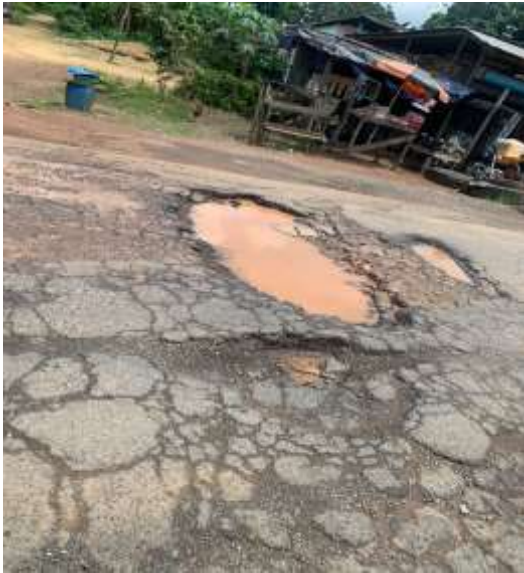
Globally, the state of the road surface on the N°5 road is catastrophic. This can be considered a contributing factor to the road accidents occurring on this road since a great part of the road is cracked, some areas delaminated, some with very deep pot holes, others experiencing rut and depression and shoulder drop off. This is due to the fact that with time, traffic, weather conditions and ground conditions expose the road surfaces to wear and tear. Ruts, cracks and unevenness in the road surface reduce driving comfort and can be a traffic hazard. Ruts and cracks in the road surface may make it more difficult to keep a motor vehicle on a steady course. Large pot holes in the road surface can damage vehicles and lead to the driver losing control of the vehicle. To avoid this, some drivers perform maneuvers to avoid areas where the road surface is not convenient by moving to the lane reserved for the opposing traffic which might be a cause of head-on collisions. All these call for high rehabilitation works on the N°5 road.

Figure 2. Delaminated and cracked road filled with potholes at Bomono

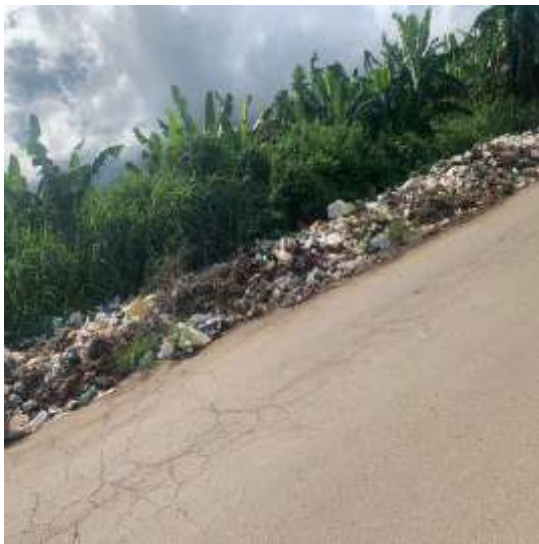
At some segments of the N°5 road (precisely at Nkongsamba) the shoulder width was occupied by dirt which turned to equally occupy a portion of the lane width thereby reducing the available space and presenting risk for side-swap collision.

Figure 4. (a) Shoulder lane filled with dirts around Nkongsamba entrance, (b) insufficient shoulder width

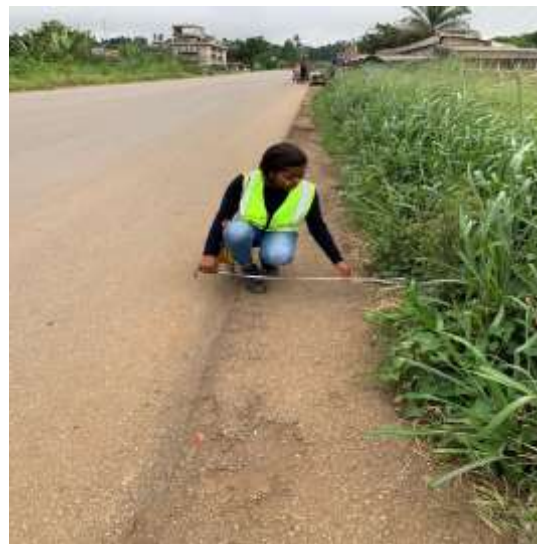
(b)

The shoulder widths where present on the N°3, N°4 and N°5 roads are reported to be an average of 1.75 m, 1.2 m, 1 m respectively. However, considering the size of the articulated trucks that have a width of approximately 2.5 m, these shoulder widths are considered very insufficient as most vehicles when they encounter a breakdown, are forced to occupy a part of the lane width thus visibility hindered and risk of head-on collision.

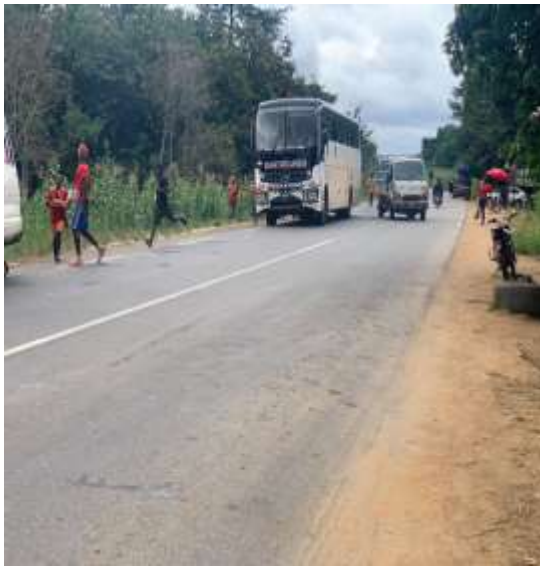
Figure 5. (a) Road lane occupied by a parked bus around Sombo, (b) Boumyebel intersection absence of signalisation and very poor channelization

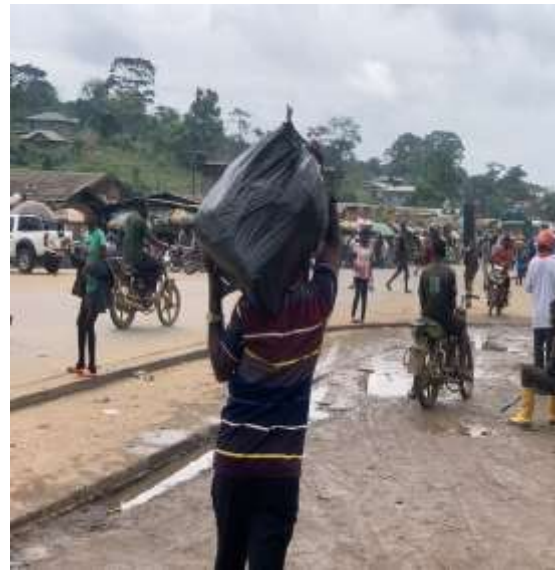
(b)

At the Boumyebel intersection, there is a notable absence of road signalizations. Considering the high population density and activity level at this point, the risk of collision between vehicles and pedestrians is significantly increased
