A Review on Seismic Performance of Existing Water Tank after Condition Position Using Non-Destructive Testing

Abstract

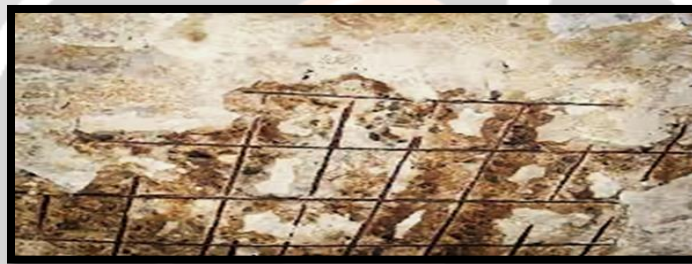
Figure. 2 Reinforcement corrosion on water tank

Collapse does not necessarily signify structural collapse only. Corrosion in concrete reinforcement is also a major contributory factor for early deterioration, leading to structural collapse. Corrosion of reinforcing steel in concrete is a serious problem from the point of persuasion of both safety and economy. There is a clear-cut need, from both the field of research in reinforcement corrosion in concrete construction and industrial requirement. Precise calculation of structural damage can assist civil engineers in achieving a structural safety and cost-effective approach to corrosion-affected concrete structures. Concrete provides corrosion resistance to the steel chemically due to its high pH and physically working as a barrier. However, reinforcing steel does corrode. The two main usual causes are a general breakdown of passivity due to the neutralization of the concrete by a reaction with atmospheric carbon dioxide and localized breakdown of the passive film on the steel by chloride ions. Therefore, it is indispensable to have authentic measurement techniques to assess the corrosion condition of the steel bars in the reinforcing concrete. Corrosion represents the full extent of the damage, or they may point to problems of more significant magnitude. The corrosion mechanism is complex, involving chemical, electrochemical, and physical operations. The parameters that impact corrosion progression is concrete cover thickness, quality of concrete, environmental conditions.
