# GEOTECHNICAL INVESTIGATION OF LANDSLIDE OCCURRED IN CHARMADI GHAT: A CASE STUDY

Sandeepkumar D S<sup>1</sup>, Anusree K Pradeep<sup>2</sup>, Athira Surendran<sup>3</sup>, Bhupathi L<sup>4</sup>, Annappa sani<sup>5</sup>

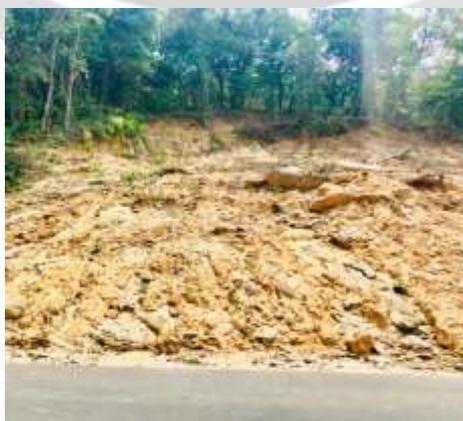
**Fig 3 : Condition of the site**

Massive landslides that occurred on Charmadi Ghat (NH-234) due to copious rains, has severely affected the free flow of traffic on the ghat highway. Landslides occurred at nine locations of the ghat. A hillock that caved-in and blocked the road, following Monday night's incessant downpour, has led to a traffic piling up for several kilometres on either side of the ghat. Motorists travelling between Mangaluru and Bengaluru via Charmadi Ghat on Monday night underwent a harrowing experience as they were stuck in a traffic jam in the middle of the ghat all night. Road clearing operations were painfully slow and arduous because as one side of the road was being cleared of slush and huge trees a landslide would occur on the other side of the highway. Vehicles remained stranded for several kilometres on either side of the stretch since Tuesday morning. Following the closure of the Shiradi Ghat (NH-75) for the second phase of the work, the second phase of the work, the traffic on Charmadi Ghat had increased. All the vehicles bound to Mangaluru from Chikkamagalur have been diverted from Kottigehara. Following the closure of Charmadi Ghat, the alternative route to Mangaluru-Bengaluru via Karkala-Kalasa-Kottigehara or Puttur-Sullia-Madikeri.
