# HIGHWAY FAILURE AND ITS MAINTENANCE

In this study, the section of NH-247 from km 35+620 to 51+420 i.e. from Wadoda junction to Kuhu (Total length-15.8 km) in district Nagpur is taken as a case study site.

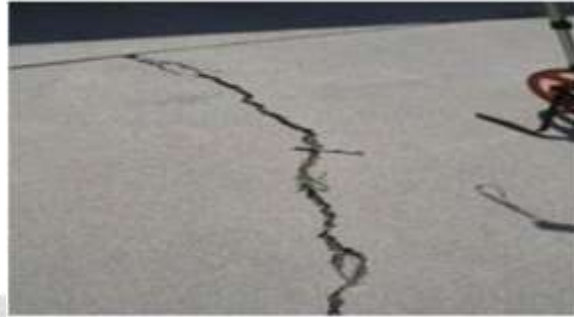
Such type of failure in rigid pavement occurs due to traffic load at repeated levels. In this type of failure, the rigid pavement surface divided in to number of pieces

**Figure 1:** Failure in Rigid Pavement by Linear / Longitudinal Cracking

Linear cracks divide the individual slabs into more than two parts and extend across the entire slab. The phenomenon of linear cracking is also referred to as panel cracking. Linear cracking will affect the riding quality of the pavement. Linear cracking will allow moisture movement in the body of pavement, as a result of which erosion of base or sub base may take place, which may lead to loss of soil support to the pavement. If not sealed the cracks may spall and disintegrate. The possible causes of linear cracking are heavy traffic, temperature gradient, curling of

slabs, moisture stresses and loss of soil support. Crack sealant can be used to seal linear cracking. If linear cracking leads to panel cracking, then the pavement is restored by full-depth repair

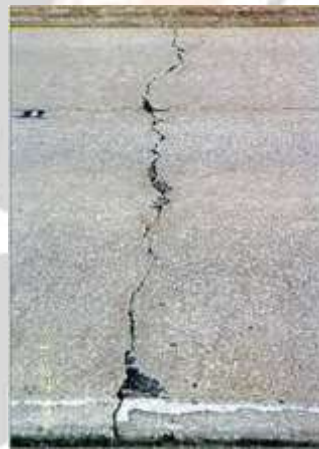
Cracks that are predominately perpendicular to pavement centreline and are not located over Portland cement concrete joints. Thermal cracking is typically in this category. This cracks may occur due to missing of saw cutting in transverse joint

**Figure 2:** Failure in Rigid Pavement by Transverse Cracking

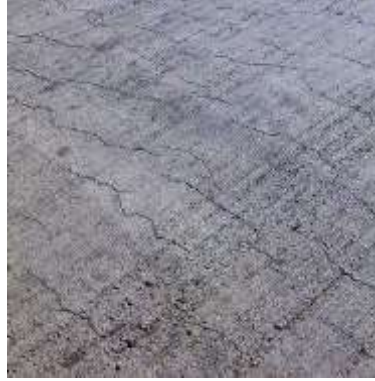
Formation of hairline cracks during setting and hardening of pavement concrete at places away from the joints are called shrinkage cracks. Shrinkage cracks are not found to extend throughout the slab thickness. Formation of plastic shrinkage cracks is seen in pavements as early as 3 to 4 hours after the pavement slab is laid, they can have width of 0.1 to 3 mm and length of up to 1000 mm. Shrinkage cracks exhibit the uncontrolled nature of slab shrinkage. These cracks allow moisture and chemical movement in the pavement that the pavement surface experience, which is detrimental to the pavement concrete if left unchecked. Severity of damage depends on the width and orientation of crack. The possible causes of shrinkage cracks are, late sawing of contraction joint, poor design of reinforcement, improper curing where the surface of the slab is allowed to dry quickly and use of high early-strength cement or admixtures that give high heat of hydration. Shrinkage cracks can be treated by means of crack sealants if they are of moderate size. Crack sealing procedure is nothing but placement of specialized material into cracks to prevent movement of water into the body of pavement.

**Figure 3:** Failure in Rigid Pavement by Shrinkage cracks

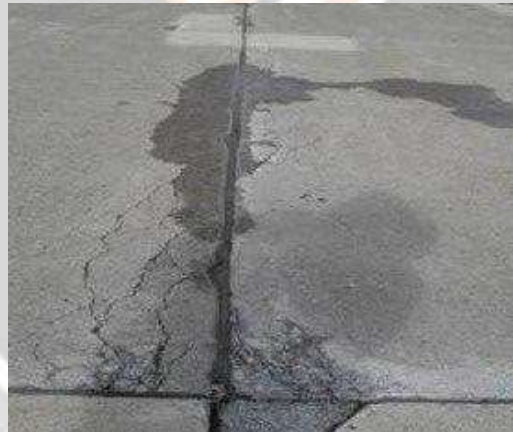
Durability cracking (“D” cracking) is characterized by sequence of crescent- shaped closely spaced hairline cracking pattern. “D” cracking occurs adjacent to joints, cracks or free edges and it normally starts from slab corners. Cracking pattern is characterized by dark coloring of the affected and surrounded area. Aggregates that are susceptible to freeze-thaw are responsible for “D” cracking and due to which roughness of pavement surface, spalling and eventual disintegration of pavement may take place “D” cracking is the problem of aggregates which are susceptible to freeze-thaw damage. The affected pavement can be refurbished by partial-depth or full-depth repair, depending on the severity of the damage but the problem may persist if the aggregates remain vulnerable to freeze-thaw attack.

**Figure 4:** Failure in Rigid Pavement by Durability Crack

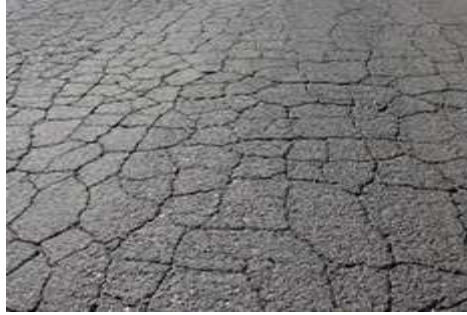
Excessive compressive stress causes deterioration in the joints, called as the spalling. This may be related to joint infiltration or the growth of pavement that are caused by the reactive aggregates. Poor quality concrete or construction technique will also result in joint spalling. Fatigue failure of concrete roads is the phenomenon by virtue of which the pavement fails under repetitive loading by a load smaller than the load that can cause failure in single application. Larger the load, smaller will be the number of repetition to cause fatigue damage. According to studies, number of factors contribute to the fatigue damage of the pavement, which include heat of hydration, low thermal conductivity, shrinkage and creep. The micro cracks formed at the early age of concrete and the micro-voids formed due to excess water capillary cavities progressively extend under the effect of repetitive loading when the ratio of tensile stress in the pavement and modulus of rupture of pavement material exceeds 0.45. Fatigue failure initiates by weakening the bond between aggregate cement paste within the tension zone till the first continuous cracks start forming from inwards from the tension face which ultimately results in reduction of effective slab

thickness and progressive shift in the neutral axis, after which full depth cracks appear, dividing the pavement slab into discrete smaller segments.

**Figure 5:** Failure in Rigid Pavement by Fatigue Cracking

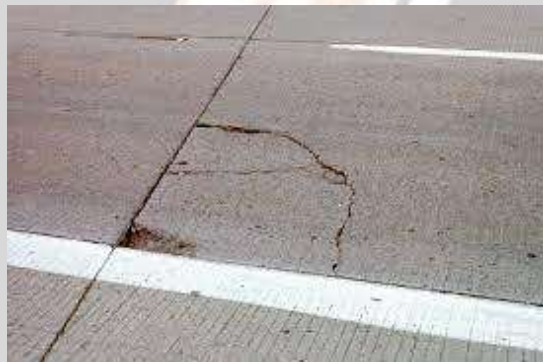
A crack that intersects the joint of the pavement near the corner of the slab (within 200 mm) is called corner break or corner crack. It can extend through the entire slab. The causes that are responsible for corner break are high corner stresses, loss of soil support, curling and warping stresses and ineffective load transfer at the joints. Corner break leads to infiltration of moisture, faulting, spalling and disintegration in the pavement slab. Full-depth repair is the solution to refurbish the pavement that suffers corner break

**Figure 6:** Failure in Rigid Pavement by Corner Break Cracking

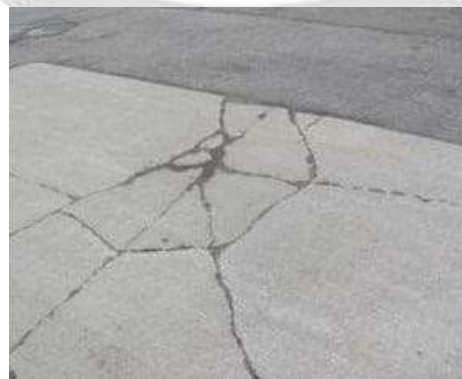
Punch-out is nothing but breaking of small portion of concrete slab into several pieces. It is localized behaviour in concrete slab. Punch-out causes roughness of the pavement surface and creates ingress to moisture into pavement and later in base and subgrade, leading to erosion of base or subgrade. Punching makes cracks to spall and disintegrates them

**Figure 7:** Failure in Rigid Pavement by Punch Out

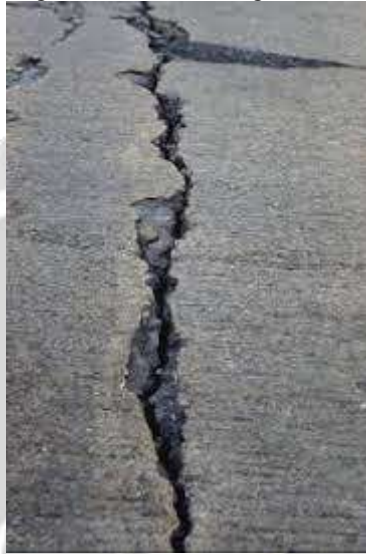
The difference in elevation between the joints is called as faulting. The main causes of failures in rigid pavements due to faulting are:

- a. Settlement of the pavement that is caused due to soft foundation
- b. The pumping or the erosion of material under the pavement, resulting in voids under the pavement slab causing settlement

The temperature changes and moisture changes that cause curling of the slab edges.

**Figure 8:** Failure in Rigid Pavement by Faulting

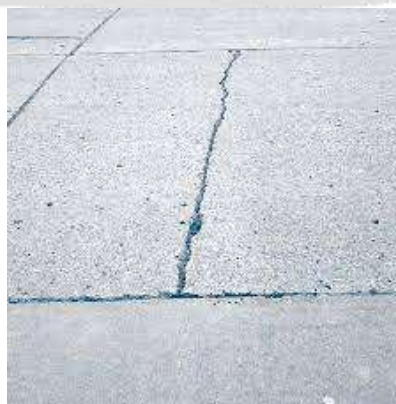
Failure of load transfer system at joints is characterized by transverse crack or corner break. The possible reasons for this type of failure are corrosion and misalignment of dowel bars. The products of corrosion which occupy certain volume will induce tensile stresses around the dowel bar and the excess corrosion weakens the dowel bar which may prematurely fail due to repeated loading. Bending of dowel bar and their closeness to the slab edge will induce localized stresses which may be high enough to break the pavement.

Usually the pavement is restored by a full-depth patch at the affected area after replacement of the failed joint load transfer system

**Figure 9:** Failure in Rigid Pavement by Failure of Joint Load Transfer System**2.1.9 Pop-Out**

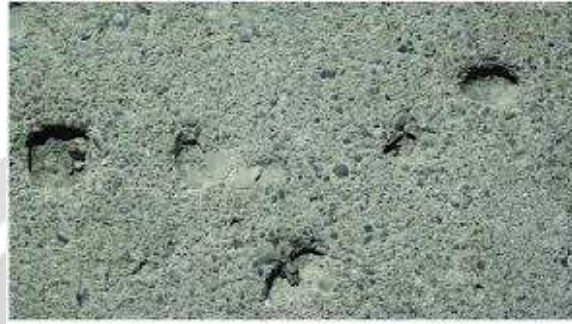
A small piece of concrete that breaks loose from the surface of pavement concrete, either due to expansive nature of aggregate or due to low quality of material and workmanship, is known as pop-out. 25 to 100 mm in diameter and 13 to 50 mm in depth are the usual sizes of pop-outs. Pop-outs cause discomfort to riding and are not repaired unless they pose threat to tyres of vehicles. Pop-outs of greater size need to be repaired by partial-depth repair

**Figure 10:** Failure in Rigid Pavement by Pop out**2.1.10 Pumping**

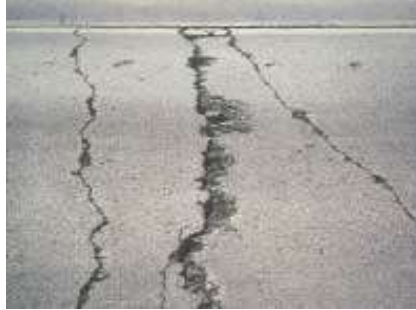
Pumping is the phenomenon of ejection of water and subgrade (or base) material through the joints and cracks or at the pavement edge due to deflection of pavement slab, when the free water accumulates underneath the slab.

Pumping is the feature of rigid pavements only because flexible pavements do not create void space under them, as their rebound capability is not sufficient to do so. Hence flexible pavements fail by rutting, shoving and so on when they are overloaded. Pavement at fills and cut areas are more prone to pumping after rainfall. Pumping takes place after certain duration of time when the pavement is incessantly subjected to heavy vehicular loads. Creation of void space under the pavement where free water accumulates is the primary cause of pumping of subgrade soil. Plastic deformation of soil and warping of the slab due to temperature gradient within slab are factors that promote the creation of void space. The entry of the water in the void space may be due to surface infiltration at the joints and edges of the pavement. The ground water is also a potential source. If the soil is not free draining the water comes out of the pavement when it deflects. The ejection of water is more pronounced at the pavement edge just ahead of joint or crack. After continuous pumping of water and soil, the structural support to the slab reduces which can lead to corner breaking, linear cracking and faulting. The repair of the pavement which is affected by pumping starts with full depth repair of the affected slab, followed by use of load transfer device (dowel bar) for effective load transfer across transverse joints created after repair. Stabilizing of slabs adjacent to the pumping area is equally important as loss of subgrade base or sub base material would have taken place after pumping

**Figure 11:** Failure in Rigid Pavement by Pumping

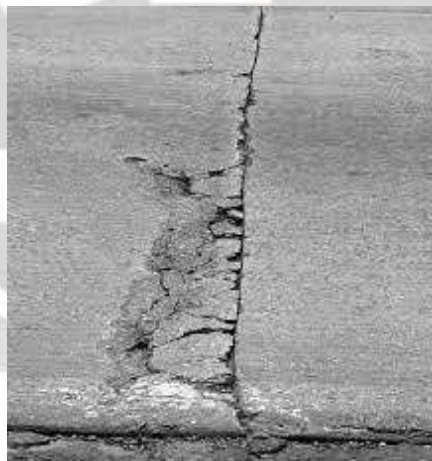
Cracking, breaking or chipping of the edges of cracks, joints and edges of the pavement, is termed as spalling. Joint spalling is usually noticed within 300 mm from the face of longitudinal or transverse joints. Corner spalling is the breakdown of the corners of the slab which is noticed within about 300 mm from the corner. Loose debris on the pavement and roughness are the problems associated with spalling. If spalling is left unattended it may severely impair the serviceability of the pavement

Possible causes of spalling are excessive stresses at joints, cracks and edges, caused by infiltration of incompressible materials and consequent expansion. “D” cracking (durability cracking) or freeze-thaw damage, weakness of pavement concrete at joints or edges due to poor workmanship, improper insertion, misalignment and corrosion of dowel bar and heavy traffic are other causes that promote spalling. Spalling is basically categorized as shallow spalling (occurs within 1/3 rd of slab thickness) and deep spalling (extends at least up to half slab thickness). Partial-depth and fulldepth repairs are the remedies for shallow and deep spalling respectively

**Figure 12:** Failure in Rigid Pavement by Spalling

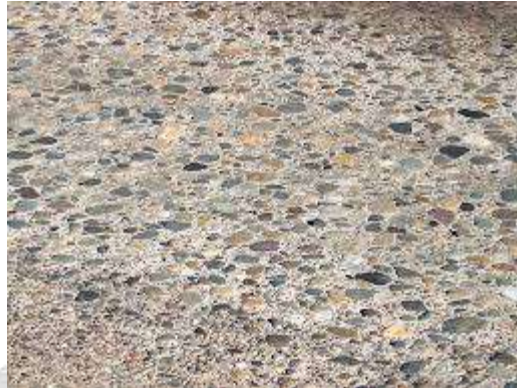
Aggregates which protrude out of cement paste with less angularity and roughness are said to be polished aggregates. In due course of time when the pavement ages due to repeated traffic loads, the protruding rough and angular particles get polished and this can occur if the abrasion value of particles is low. Excessive studded tyre wear also contributes to polishing of aggregates. The obvious problem of polished aggregates in pavement

is the reduction of skid resistance, which may lead to riding discomfort and if the severity increases it may lead to road accidents.

**Figure 12:** Failure in Rigid Pavement by Aggregates with polished surfaces
