# Piston Analysis of IC Engine

Chetan S.Dhamak<sup>1</sup>, Bhuvanesh D.Patil<sup>2</sup>, Nikhil T.Chavan<sup>3</sup>, Vitthal R.Dharmashale<sup>4</sup>

<sup>1,2,3,4</sup> Maharashtra Institute of Technology, Pune, Maharashtra, India

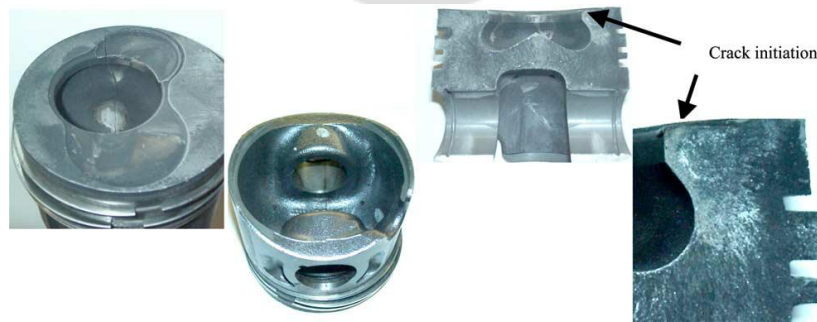
**Fig.5 -**Diesel engine piston with a crack from one side of the pin hole to the other pin hole going through the head of the piston

On piston in Fig. 3 it seems by fractographic analysis that the crack initiated at the pin-hole. On pistons in Figs. 4 and 5 the crack initiated on the piston head near the combustion chamber. A FEM analysis, Fig. 6, was made to piston of Fig. 5 and the results show that in pistons with a bowl combustion chamber, besides the pin holes (and in this particular case on the curvature radius on the inner side of the piston top) there are also two regions at the piston head where there exist a stress concentration. These two areas are located on the same vertical plane that contains the pin holes.

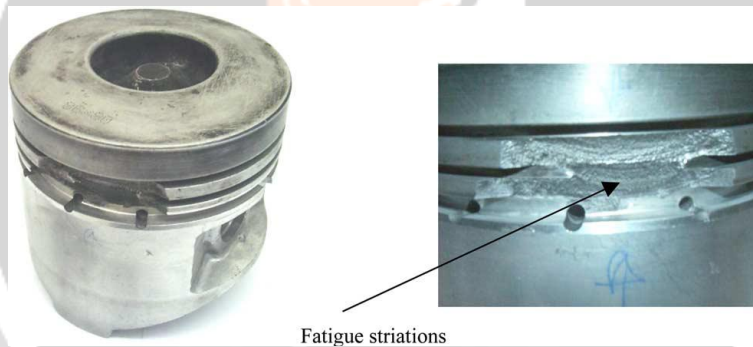
**Fig. 7-** Engine piston with damaged grooves: (a) piston; (b) detail of damaged grooves.

Another typical fatigue damage occurs on piston compression grooves. Fig. 7 shows one damaged piston. It is clear by Fig. 7(b) that the mechanism is fatigue. The striations clearly show the propagation of the crack. In Fig. 8 a simulation is made for stress analysis in piston grooves. It is clear that there is a stress concentration on a stress radius of the groove when the compression ring is not inside the groove – the inner side of the ring is located at mid distance of the groove depth. For a comparison, a simulation of the maximum Von Mises stress with the ring inside the groove (close to the piston wall) presented a maximum stress of about one third of the one shown in Fig.8(b), where the inner side of the ring is located at mid distance of the groove depth. Thus there is an exponential growth of the stress when the distance between the ring and the piston wall increases. The same is to say that there is an increase in the stress at the piston groove when the clearance between the piston and the cylinder increases.

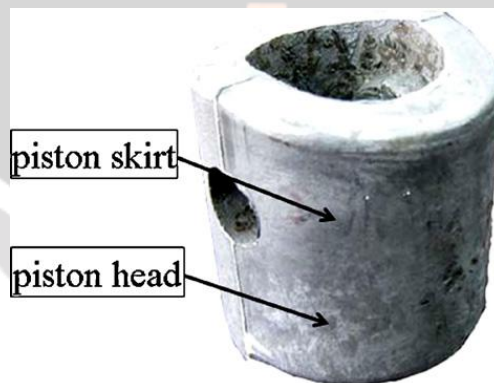
Fig.15-The clean piston

Fig. 14 shows as cast pistons directly taken from the mold. Only the upper and lower pistons were used for material characterization. In Fig. 15 is shown the clean piston. The piston has clear outlines and a smooth surface and was obtained with the required dimensions. The clean piston was machined to create a piston with grooves, shown in Fig. 16. The piston with grooves was then cut along the axis by EDM, and the cross-section morphology, as shown in Fig. 17, revealed many SiC particles gathered in the piston head. In contrast, there are no SiC particles in the piston skirt. This observation indicates that the SiC particle segregation was achieved under a centrifugal force, and eventually Al alloy-based composite pistons with partial SiC particle segregation were manufactured by centrifugal casting.
