# ANALYSIS OF BEAM COLUMN JOINT SUBJECTED TO SEISMIC LATERAL LOADING

Ms. Shubhangi Balaji Dalave.<sup>1</sup>, Prof. A. N. Shaikh <sup>2</sup>

<sup>1</sup>Department of Civil Engineering, M. S. Bidve Engineering College, Latur

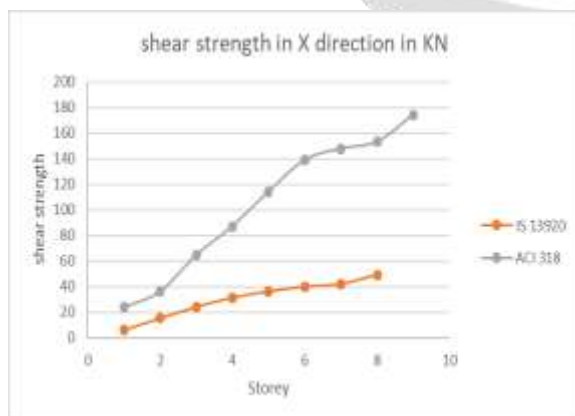
**Graph 6.1: Shear strength in X direction in KN**

Above graph shows Shear strength in X direction in KN for IS 13920 and ACI 318 as we can see that ACI 318 is the maximum shear strength is 174.1029 and IS 13920 is minimum shear strength is 49.27082.

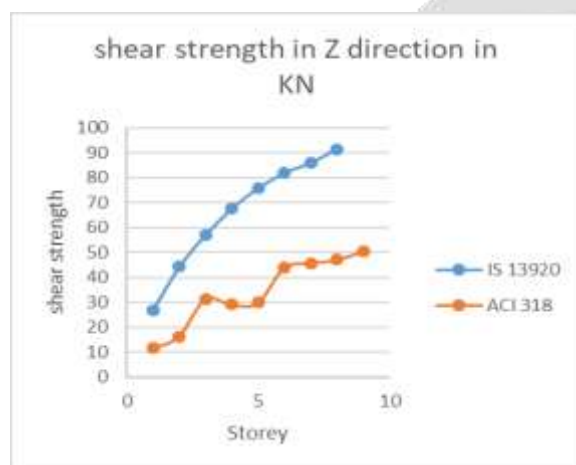
**Graph 6.2: Shear strength in Z direction in KN**

Above graph shows Shear strength in Z direction in KN for IS 13920 and ACI 318 as we can see that IS 13920 is the maximum shear strength is 91.52865 and ACI 318 is minimum shear strength is 50.45625

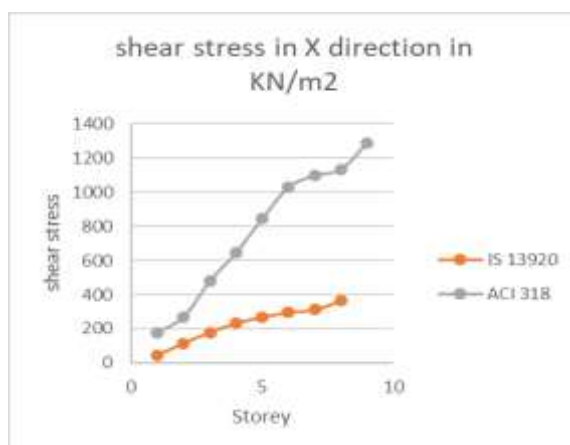
**Graph 6.3: Shear Stress in x direction in KN/m2**

Above graph shows shear stress in X direction in KN/m2 for IS 13920 and ACI 318 as we can see that ACI 318 is the maximum shear stress is 1289.651 and IS 13920 is minimum shear stress is 364.969.

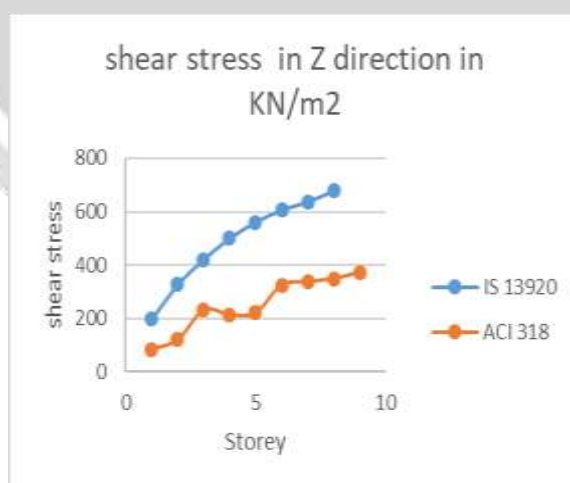
**Graph 6.4: shear stress in Z direction in KN/m2**

Above graph shows for shear stress in Z direction in KN/m2 IS 13920 and ACI 318 as we can see that IS 13920 is maximum shear stress and ACI 318 is minimum shear stress 373.75

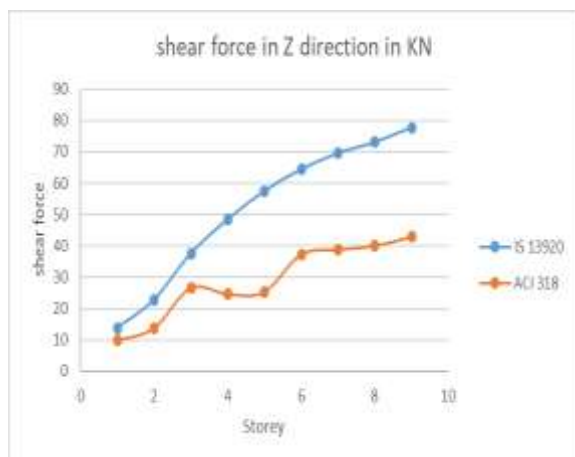
**Graph 6.10: Shear force in Z direction in KN**

Above graph shows Shear force in Z direction in KN for IS 13920 and ACI 318 as we can see that IS 13920 is maximum Shear force is 77.799 and ACI 318 is minimum Shear force is 42.888.

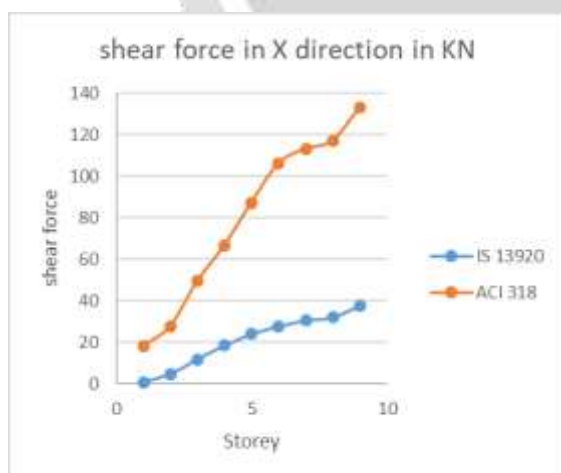
**Graph :6.15 shear force in X direction in KN**

Above graph shows Shear force in X direction in KN for IS 13920 and ACI 318 as we can see that ACI 318 is maximum Shear force is 133.1883 and IS 13920 is minimum Shear force is 37.692

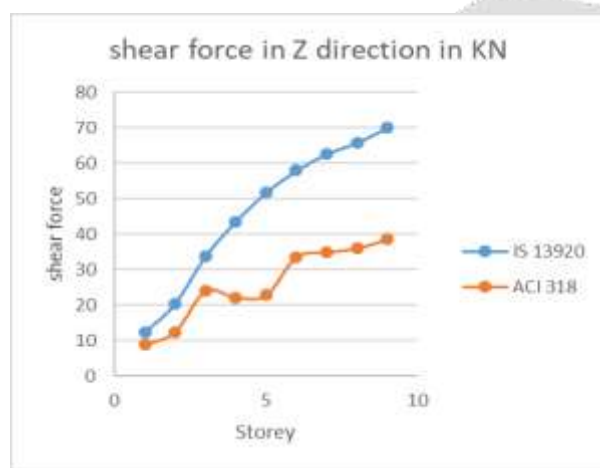
**Graph :6.16 shear force in Z direction in KN**

Above graph shows Shear force in Z direction in KN for IS 13920 and ACI 318 as we can see that IS 13920 is maximum Shear force is 70.0191 and ACI 318 is minimum Shear force is 38.5992

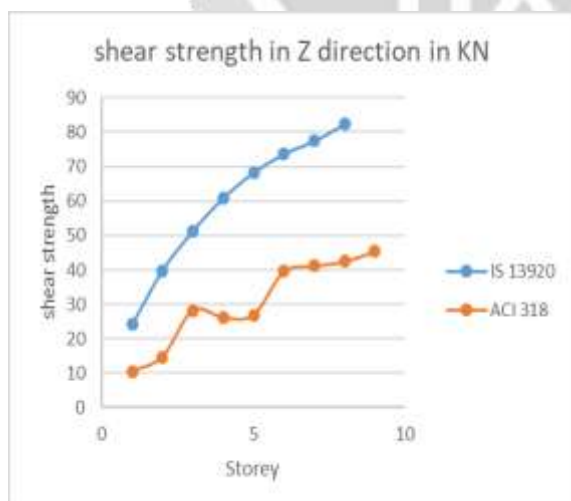
**Graph: 6.18 shear strength in Z direction in KN**

Above graph shows Shear strength in Z direction in KN for IS 13920 and ACI 318 as we can see that IS 13920 is the maximum shear strength is 82.37579 and ACI 318 is minimum shear strength is 45.41063.

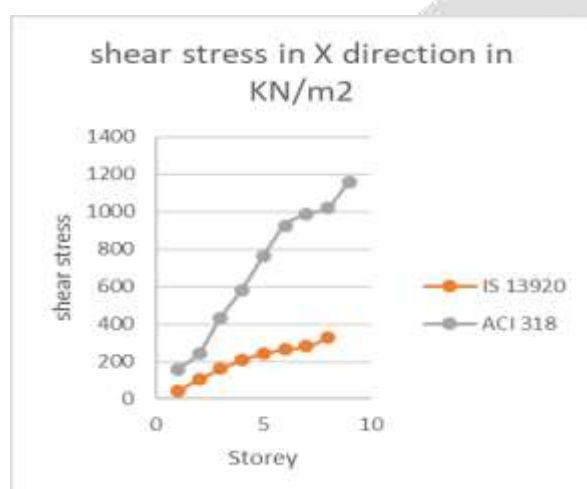
**Graph: 6.19 shear stress in X direction in KN/m<sup>2</sup>**

Above graph shows shear stress in X direction in KN/m<sup>2</sup> for IS 13920 and ACI 318 as we can see that ACI 318 is the maximum shear stress is 1160.686 and IS 13920 is minimum shear stress is 328.4721.
