# DISTURBANCE ANALYSIS OF 3 PHASE INDUCTION MOTOR IN FUEL OIL PUMP WITH MOTORCURRENT SIGNATURE ANALYSIS METHOD IN PT X

Badaruddin

*Electrical Engineering Departement, Faculty of Engineering, Universitas Mercu Buana  
Jl. Meruya Selatan, Kembangan, Jakarta 11650, Indonesia*

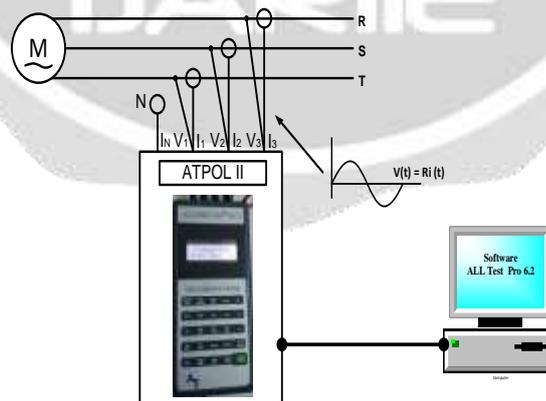
Figure 1. Testing Process Circuit

Measurement steps are carried out as follows:

- Work preparing (start motor and prepare equipment).
- Taking tools from carrying case.
- Connect each Voltage and Current probes to ATPOL II.
- Install the probe on the Source (Busbar, Power Cable, and Current Transformer) sections.

- Install the Voltage Probe (V1, V2, V3) according to the order of phase (e.g. R, S, T, then attach V1 to phase R, V2 on Phase S, & V3 at T phase).
- Install Current probe (I1, I2, I3) in order of phase. For example R, S, T, then attach I1 to phase R, I2 in phase S, and I3 in phase T. Be sure to use the Current probe according to the measuring Range.
- Setting ATPOLL II & Measuring Motor (motor in operating condition). The data retrieval process is done for one minute after completion of capture data [7].

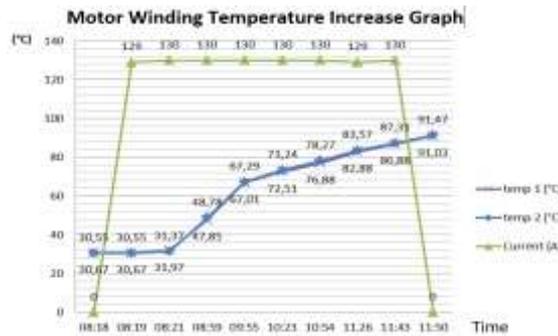
Figure 2. Motor Winding Temperature Increase Graph

Based on the result of field identification obtained deviation parameter of motor at the time of operation. Abstracting of daily monitoring data parameters is an increase in winding temperature of the motor by approaching the alarm limit of 110 ° C, at the time of data retrieval rise in temperature is clearly visible at the beginning of the motor start can be seen in Figure 2.

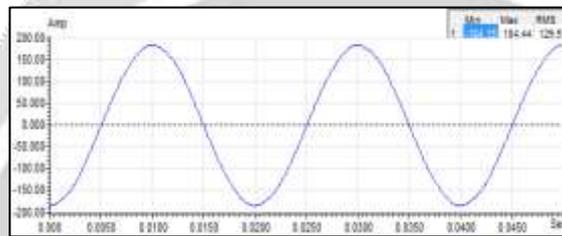
Figure 3. Raw Current Spectrum

- a. Raw Current Spectrum Current signal in time domain as shown in Figure 3 below.

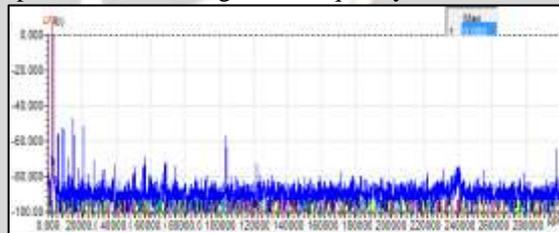
Figure 4. Raw Current Frequency Spectrum

- b. Raw Current Frequency Spectrum Current signal in frequency domain as shown in Figure 4, 5, 6, 7 below.

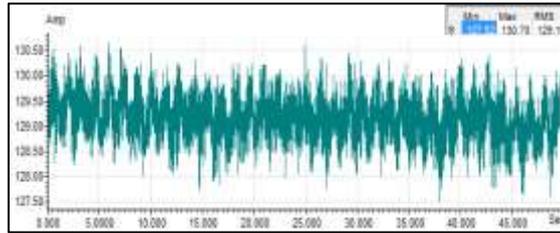
Figure 5. Demodulated Current Spectrum

- c. Demodulated Current Trace

Phase-1	phase-2	phase-3	Average /Total	Unit
Power Factor	0.891	0.883	0.89	0.888	-
Real Power	27.04	26.78	27.16	80.98	KW
Reactive Power	13.809	14.207	13.941	41.957	KVAR
Apparent Power	30.362	30.315	30.529	91.206	KVAR
Running Current	129.2	129	129.8	129.3	Amp
Line Voltage	407.2	407.1	407.3	407.2	Volt
Impedance	3.152	3.156	3.138	3.148	
Motor Load				82	%
Output Power				74.25	KW
Motor Efficiency				91.7	%

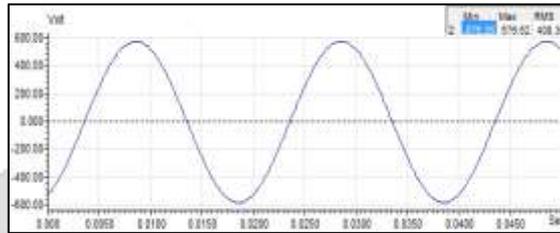
Figure 6. Raw Voltage Spectrum

d. Raw Voltage Spectrum

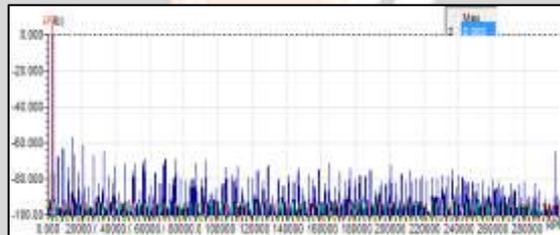
Figure 7. Raw Voltage Frequency Spectrum

e. Raw Voltage Frequency Spectrum

Running Speed = 49.561 Hz [2973.6 RPM]

Pole pass frequency = 0.732 Hz [44 RPM]

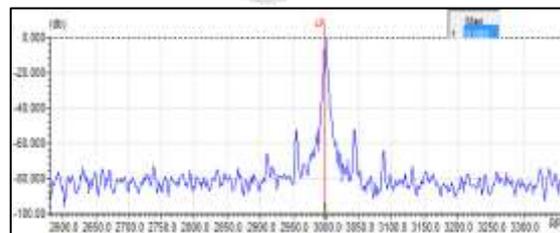
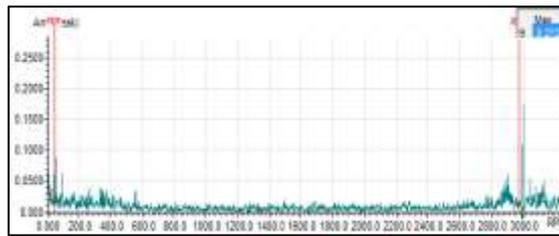
The rotor bar analysis is performed to determine the extent of damage to the rotor bar. The current spectrum of the measurement results in the frequency domain (Raw current spectrum) can be shown as in Figure 8, 9 below:

Figure 8. Interfered Motor Current Spectrum

Figure 9. Demodulated Current Spectrum

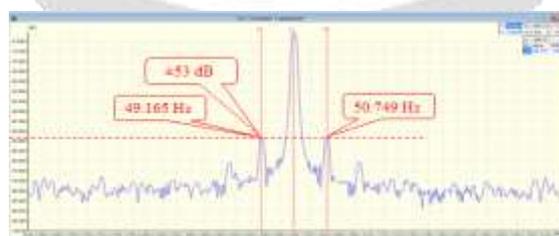
Figure 10. Side Band Frequency next to Line Frequency

Based on the sideband frequency value of 0.792 Hz, then it can be interpreted that the sideband that appears around the frequency line value is:

$$\begin{aligned}
 \text{Sideband Frequency}_{-12} &= \text{Frequency Line} \pm \text{Appeared Sideband Frequency} \\
 \text{Sideband Frequency}_{-1} &= 49.957 \text{ Hz} - 0.792 \text{ Hz} = 49.165 \text{ Hz} \\
 \text{Sideband Frequency}_{-2} &= 49.957 \text{ Hz} + 0.792 \text{ Hz} = 50.749 \text{ Hz}
 \end{aligned}$$

The value of the sideband frequency that appears between the frequency lines can be shown in Figure 10 below.

To know indication of rotor bar damage can be seen amount of decrease that happened between frequency line with sideband frequency. The determination of the presence and absence of rotor damage shall be in accordance with the standard table of the EASA (Electrical Apparatus Service Association). Based on EASA standard table it can be seen that the sideband Frequency value that appears between the frequency lines is 53 dB so it can be said that the Fuel Oil Pump motor is identified as a rotor bar failure i.e. condition level 3 / moderate level C: 3 (45- 54 dB).

After analyzing the possible source of the problem then the authors provide some recommendations to overcome the disruption of the motor such as in accordance with the standard EASA (Electrical Apparatus Service Association) should be monitored / checked periodically with more frequent intervals and monitored its development. Because there is a marginal condition fault on the motor rotor bar. Furthermore, to obtain the results of a more complete analysis can be tested with other methods such as motor and pump vibration testing, Infrared Thermovision testing or testing with other technologies.

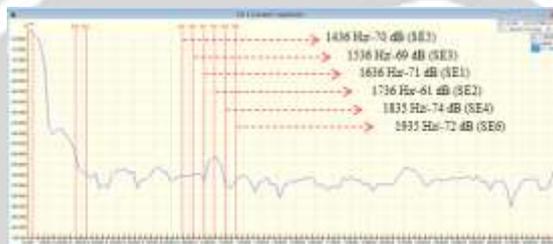
Figure 11. High Frequency Domain Current Spectrum

Testing of static eccentricity is done on load motor condition. The current spectrum used in this analysis uses the current spectrum in the high frequency domain. The test results are shown on the Figure 11 below.

$$\begin{aligned}
 \text{Static Eccentricity Frequency} &= (Rb \times Rf) \pm (N \times Lf) \\
 &= (34 \times 50) \pm (N \times 49.561) \\
 &= 1700 \pm (N \times 49.561)
 \end{aligned}$$

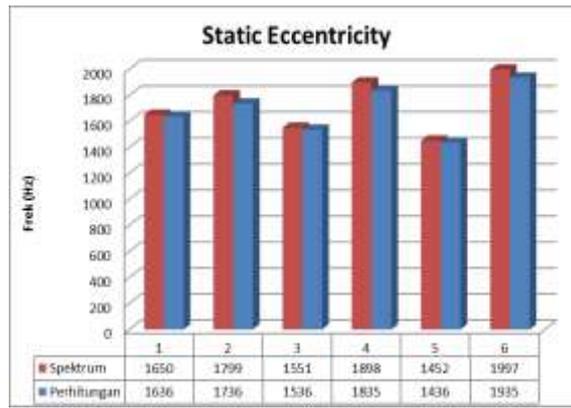
Figure 12. Static Eccentricity Comparison

Based on the comparison of current spectrum results in high frequency that static eccentricity value is not the same and much different from the calculation results. And based on current spectrum pattern at low frequency also does not show any static eccentricity disturbance.

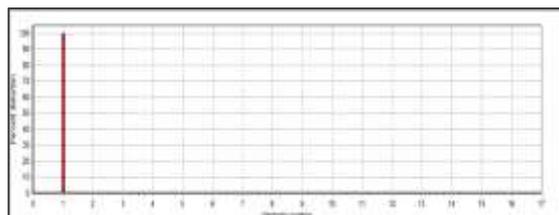
Figure 13. Current Harmonic Distortion Plot

Based on the experimental data, results the current imbalance value is 0.36%, the motor industry has set the maximum unbalance current maximum level of 10% with measured THD-I equal to 0.677%. So it's still within safe limits.

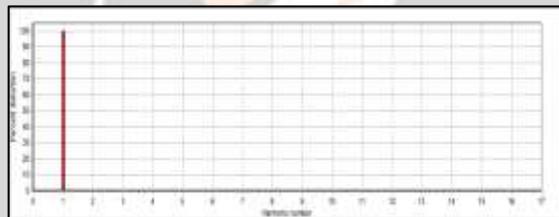
Figure 14. Voltage Harmonic Distortion Plot

Based on the result of experimental data obtained equal to 0.02% voltage imbalance value, motor industry has set maximum unbalance level of Voltage maximum 5% with THD-V measured equal to 0,248%. So it's still within safe limits. The final result of the analysis performed by Motor Current Signature Analysis method on the motor obtained the results as in Figure 15 below.

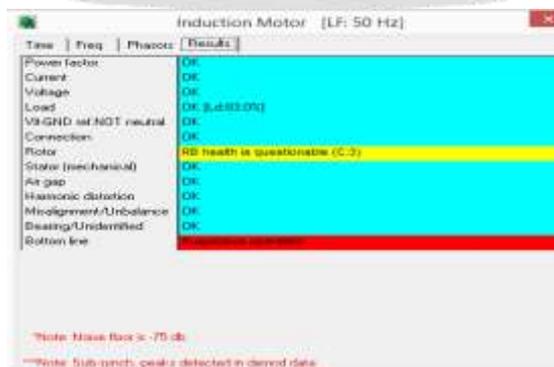
Figure 15. Atpol II Final Report Analysis

Testing on the motor is done when the motor is operated with a load of 83% of the maximum motor load. From the test results obtained the results, found that the motor Fuel Oil Pump identified rotor bar damage i.e. the condition level 3 / moderate level C: 3 (53 dB) according to EASA standard, there may be 1 rotor bar fault (crack / damaged) that causes temperature motor rises, then there is no damage due to eccentricity on the motor, 0.36% for current balance and the voltage on the motor is still within the normal limit of 0.02%.
