DETECTION OF DEFECTS IN SOLAR PANELS USING THERMAL IMAGING BY PCA AND ICA METHOD

PG Student [CSE], Dept. of EIE, HCST, Farah, Mathura, Uttar Pradesh, India¹

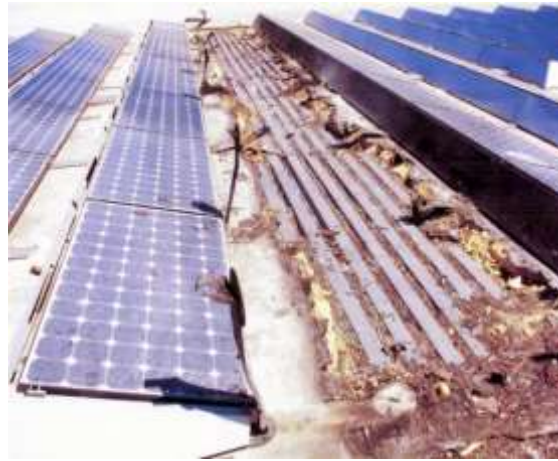
Fig 1.1(a) fire hazard in a 383 kW PV array in Bakersfield, California in 2009

Several severe fire hazards have been reported in PV systems due to non detection of fault. For example- Fig. 1.1(a) shows the fire hazard which took place in a 383 kW PV module in Bakersfield, California in 2009. Another fire hazard was occurred in a 1 MW PV power plant in Mount Holly, North Carolina, in 2011 shown in fig 1.1(b). In both these cases, the fault remained unnoticed and hidden within the system until the hazard caused catastrophic fire and shut down the system completely.

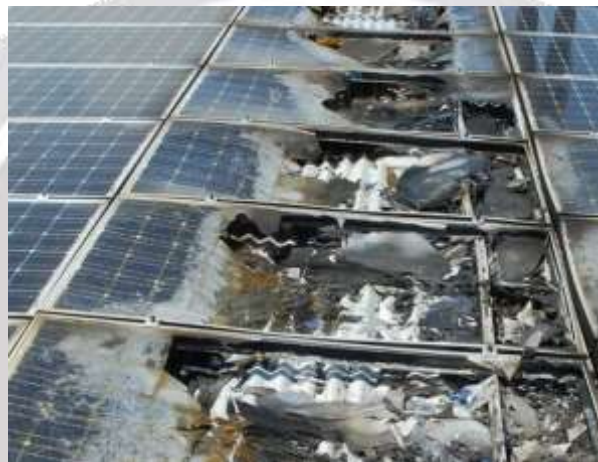
Fig 1.1 (b) fault occurred in 1 MW PV power plant in Mount Holly, North Carolina, in 2011

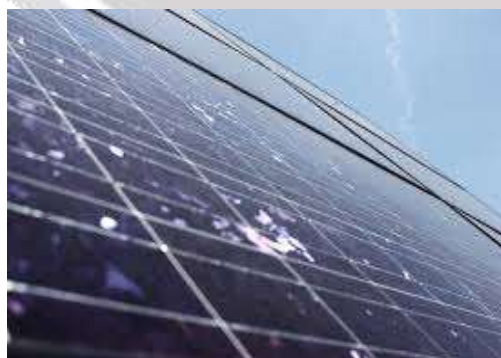
Fig 4(a) defected input image

Figure 4 (a) shows a defected input image of a solar panel
